## TEST CERTIFICATE

**CERTIFICATE NUMBER** 11368/01 – Issue 1

Description	Model Number	Serial Number
Infra-Red Patio Heater	HLW 15	Not Serialised

BS EN 60529, 1992, IP66 Category 1

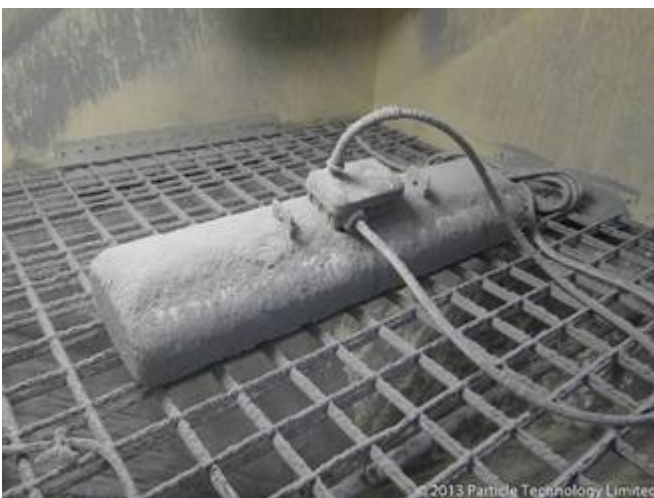
On completion of the test excess dust was removed by light brushing to allow inspection. No conspicuous damage was noticed on the exterior of the unit, there was no visible dust ingress into the electrical enclosure of the Patio Heater.

**Figure 1 – HLW 15 after IP6X dust test**

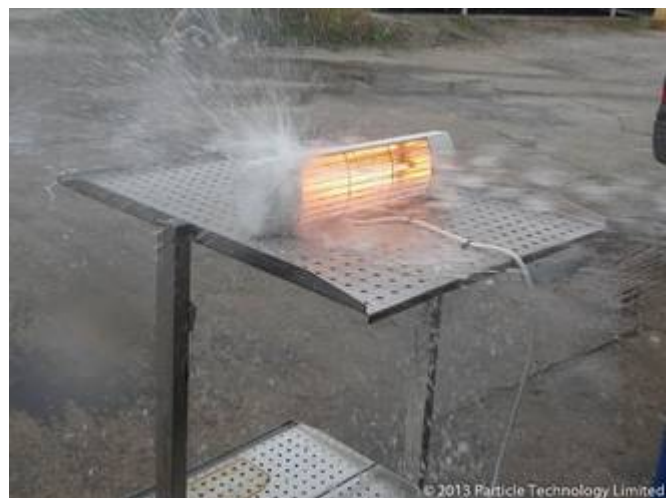
The HLW 15 patio heater remained powered and operational throughout the water testing.

On completion of the water test excess water was removed to allow inspection; there was no visible water ingress into the electrical enclosure of the Patio Heater.

**Figure 2 - HLW 15 during IPX6 Water Test**
